dsPIC33CH512MP508 Family Silicon Errata and Data Sheet Clarification

The dsPIC33CH512MP508 family devices that you have received conform functionally to the current Device Data Sheet (DS70005371E), except for the anomalies described in this document.

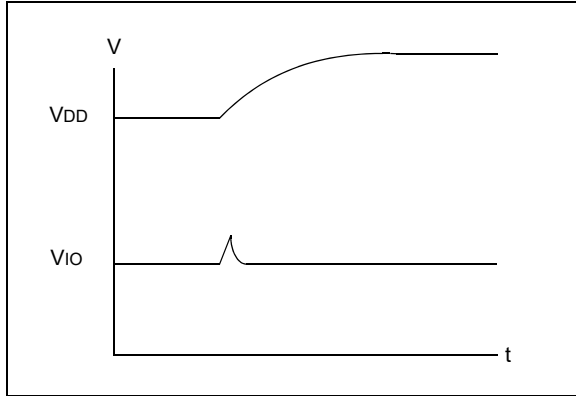
FIGURE 1-1: I/O RAMP

During a fast device power-up, when the VDD ramp is less than 4 mS, the I/O pins may drive up to 100 μ A current for a duration of up to 10 μ S (Figure 1-1).

Example applications affected may include complementary power switches, where a transient current shoot-through might occur. High-voltage applications with complementary switches should power the high-voltage 200 μ Sec later than powering the dsPIC[®] device to avoid the current shoot-through. This behavior is specific to each device and not affected by aging.

1. Slow down the VDD ramp time (greater than 4 mS for VDD to ramp 0V to 3.3V).
2. Ensure the circuitry that is connected to the pins can endure this pulse.
